Products tested in USA for blast test – Shock Tube Testing of Window Systems

Shock Tube Testing for Window Film Systems

February 2016
San Antonio, Texas

ABS Consulting Project Number 3615475

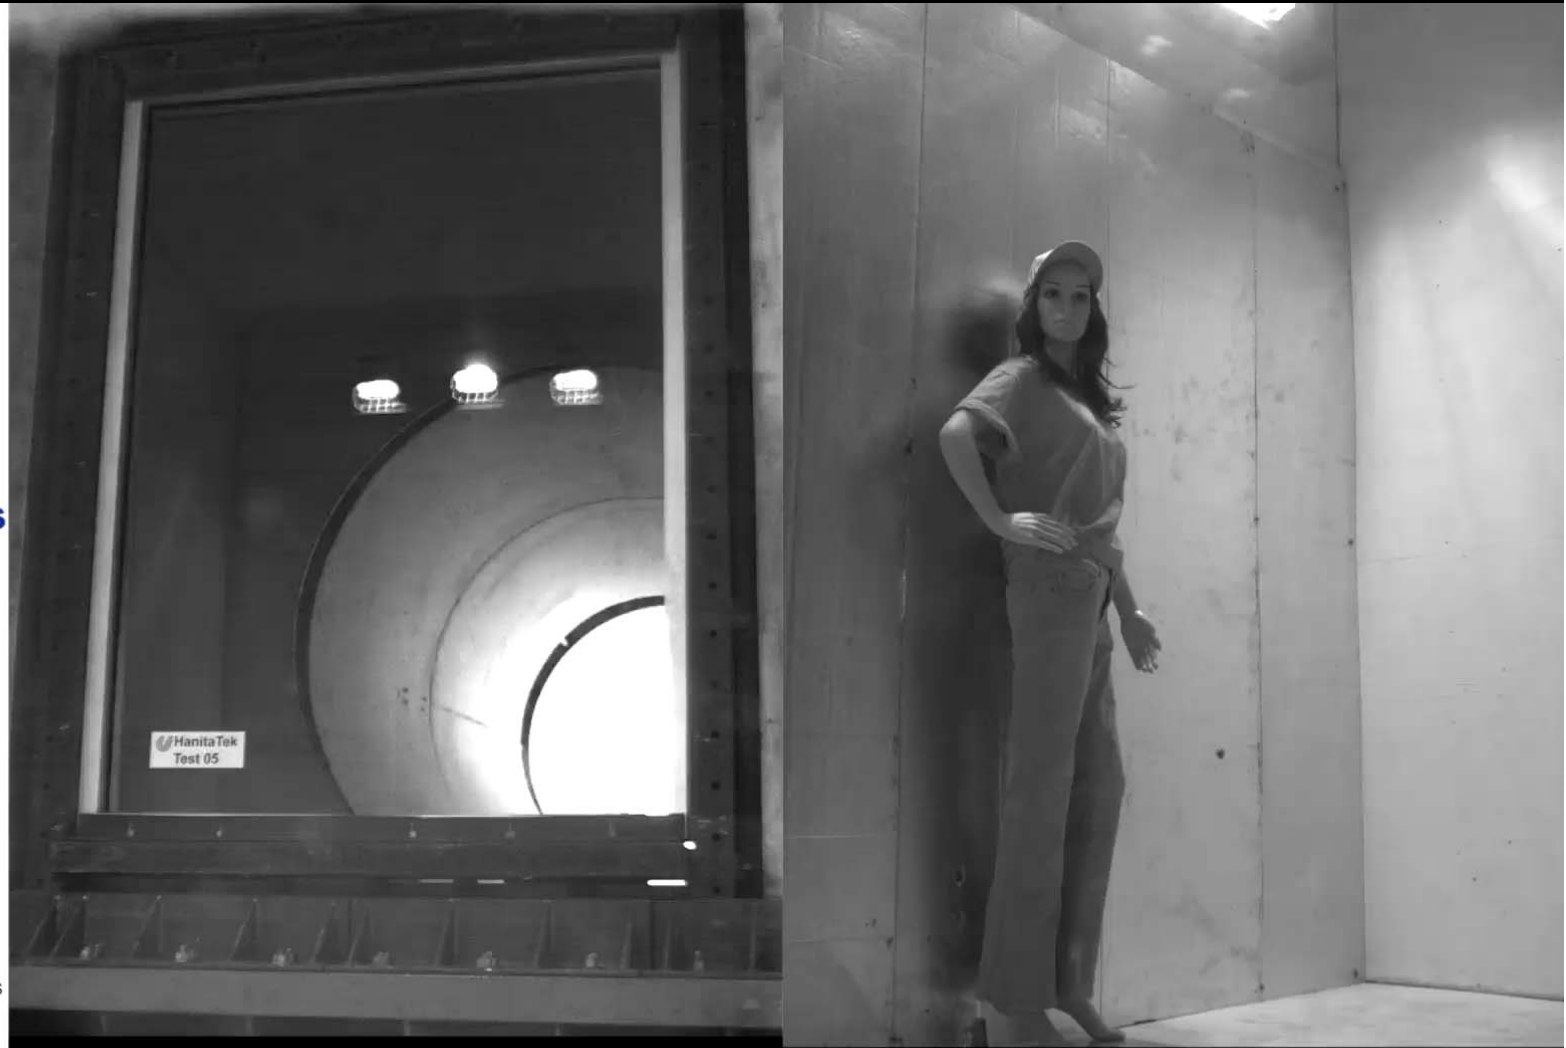
**Test 05
January 18, 2016**

No Film

**Applied Load:
Pressure: 4.9 psi
Impulse: 31.7 psi-ms**

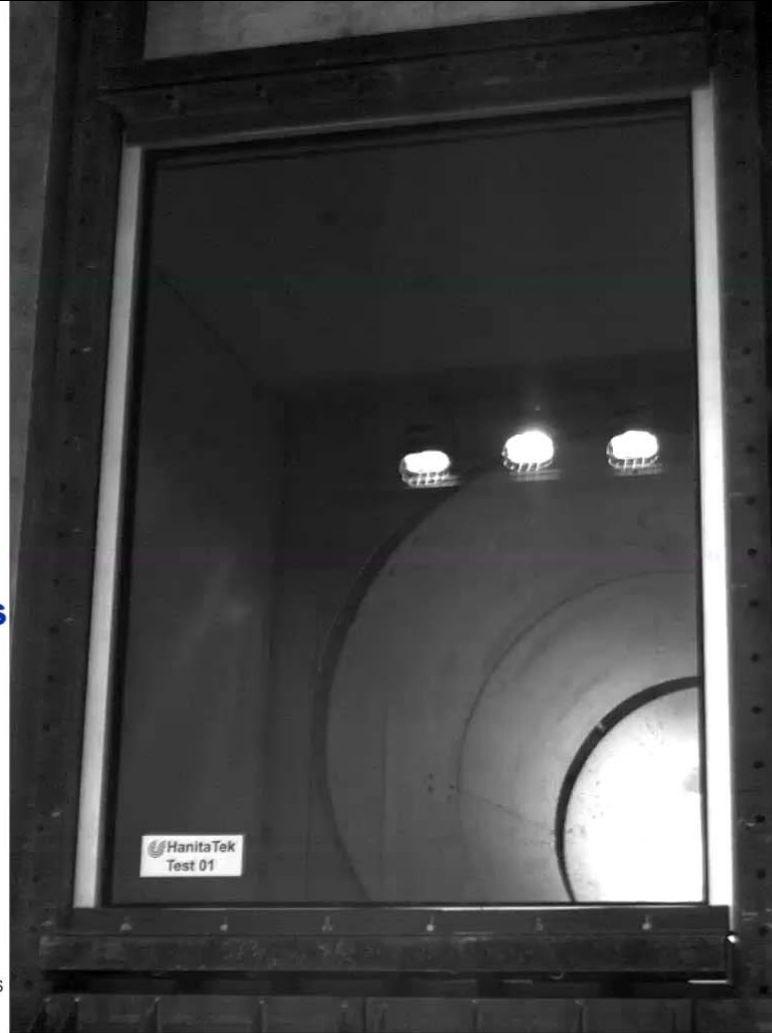
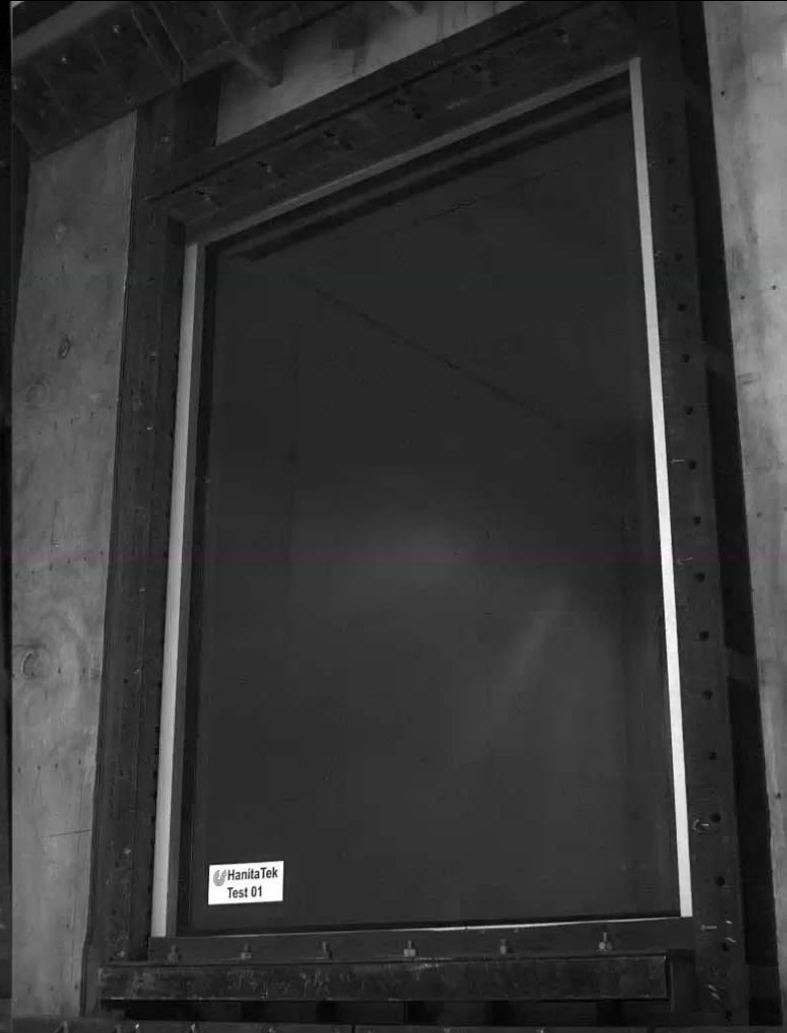
**Test 01
January 18, 2016**

**Film System:
8 mil Film Anchored
4 Sides Wet Glaze**

**Applied Load:
Pressure: 4.5 psi
Impulse: 26.0 psi-ms**
